REVIEW OF PATHWAYS IN BLACKBURN HAMLET

Introduction

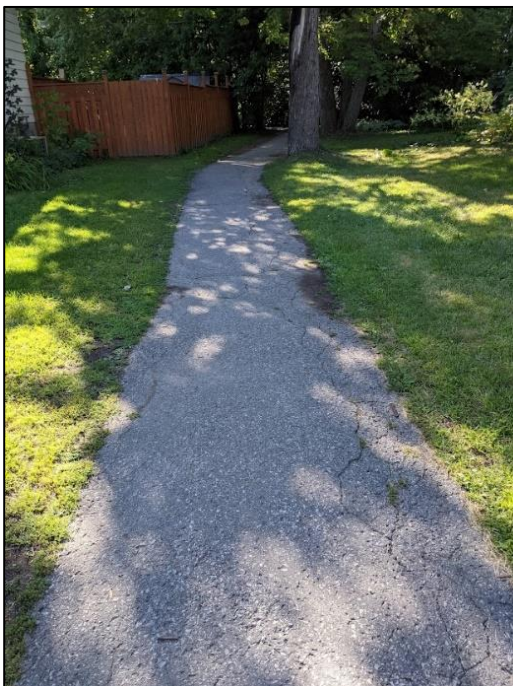
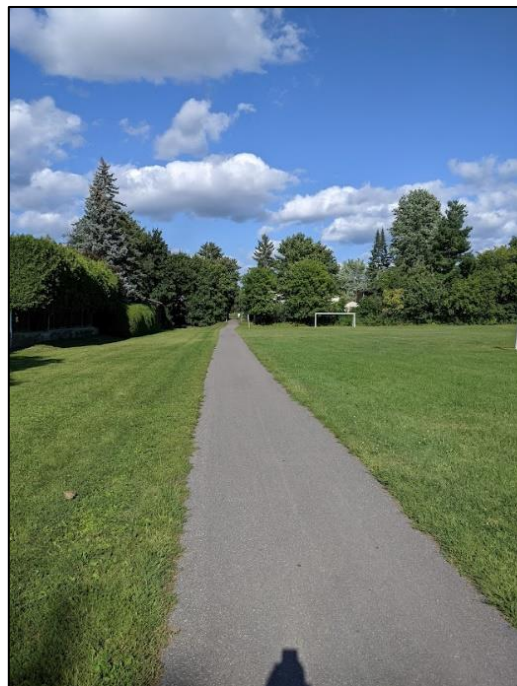
One notable observation was the width variance of the pathways, and in particular, the width of the asphalt. The pathways width of asphalt can vary from 0.9 metres (3 feet) to 2.1 metres (7 feet).

The width of the pathways is important, especially when multiple users are using the pathways or passing one another. In our time of Covid rules a proper distance between residents is essential.

Develop a plan to replace the asphalt in areas where the asphalt has seriously disintegrated or is completely missing. The plan should include adopting a standardized width of asphalt when the asphalt is replaced.

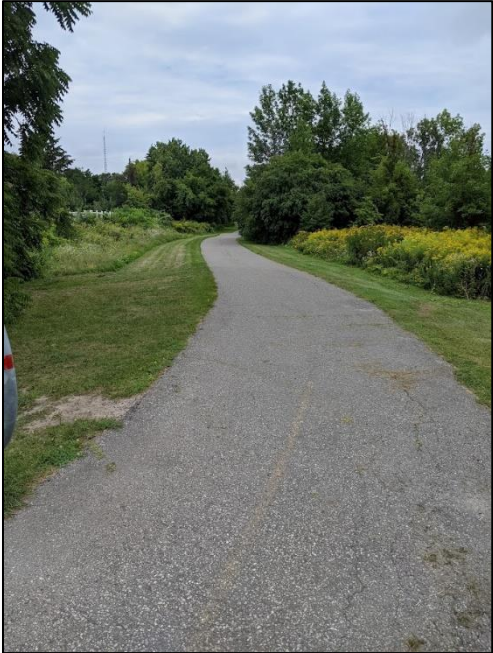
Note: Some other areas of the city, such as Ottawa South, have a standardized width of 2.1 metres.

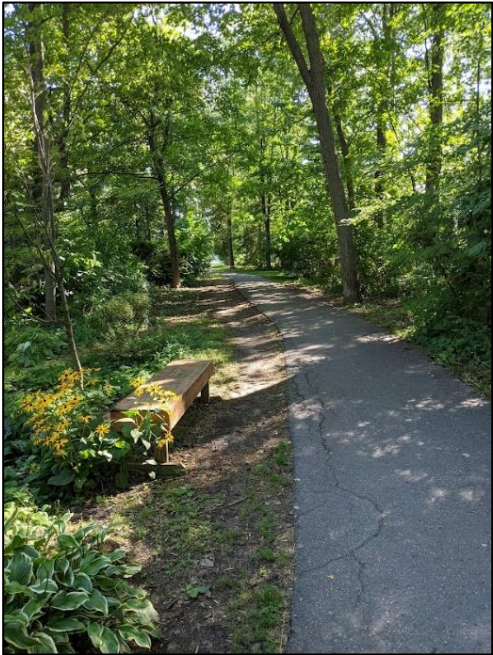
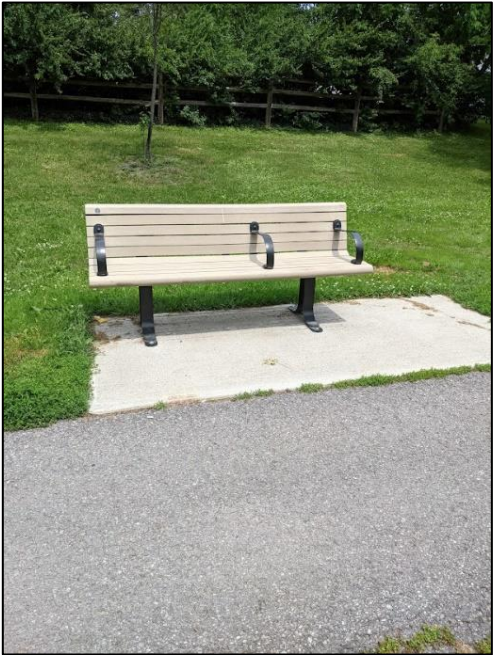
Requests were also made for more benches along the pathway system. Many residents would like to stop and enjoy the ambiance of the forest canopy or embrace the quietness of their surroundings. The bench style is preferred.

Install benches across more areas of the pathway system. Consider engaging private interests, such as Lafarge, for their assistance.

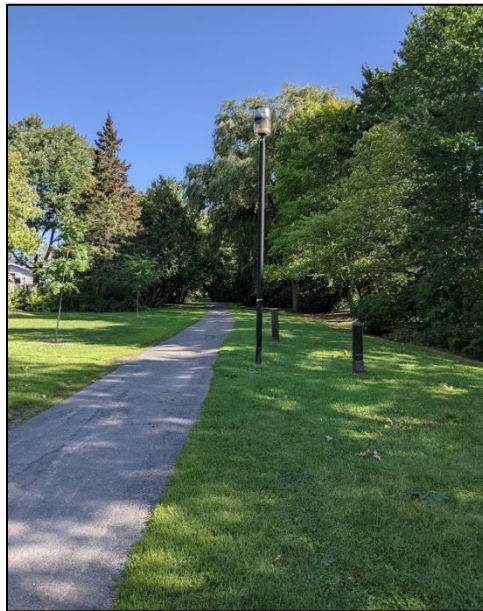
Many residents have expressed about the lack of lighting along the pathways, particularly in the Diceman and Bush Park areas where large trees restrict sunlight. Light posts are located sparingly throughout the pathway system. Establishing what lighting is needed will require a professional assessment.

Request the city to review the present lighting system and present what measures could be done to enhance the visibility along the pathway system.

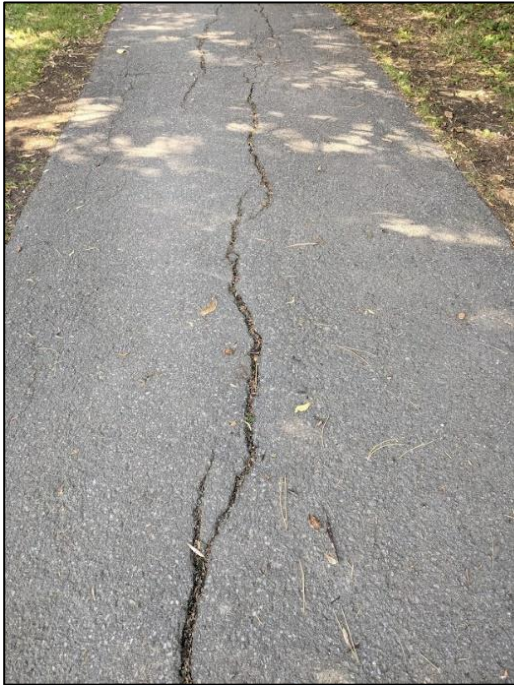
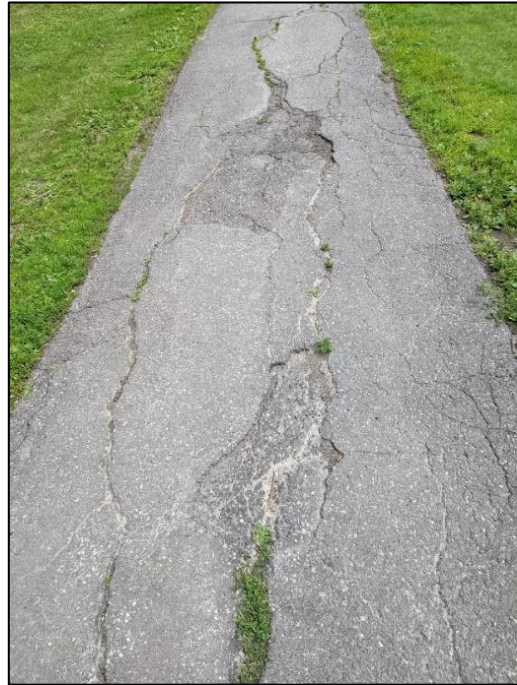
The pathways in this area leads to the Emily Carr School, the swimming pool, the tennis court, and the park's playground. They connect to roadways of Bearbrook, Innes and Northpark. The pathways in this area are mostly in good condition, but some areas have deep cracks, in particular the pathway leading to North Park and by the swimming pool. The width of the pathways is between 1.5 and 1.8 metres.

Develop a plan to address the areas where the severe cracks in the asphalt constitute a safety concern.

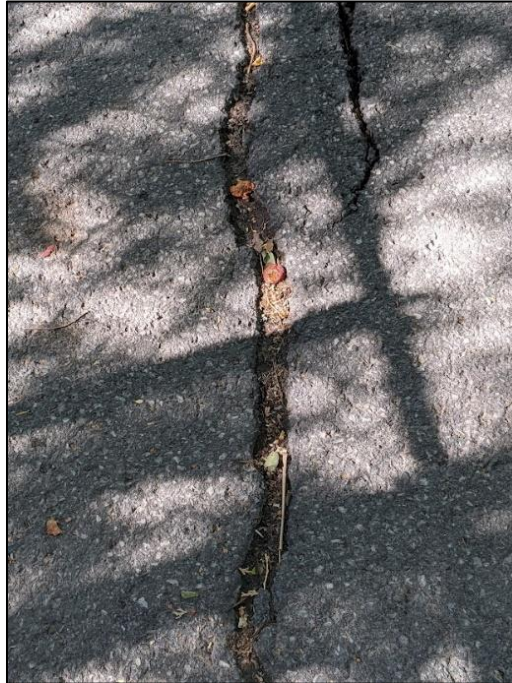
The asphalt needs maintenance for the many cracks, especially for the pathway leading from the park to the Glen Ogilvie School. Consideration should be also given for replacement of asphalt near L'ecole Ste.Marie. There is also an overgrowth of the hedge that forces pedestrians and bicycles to move off the pathway. This overgrowth condition can also hamper winter maintenance. The width of the pathways is mostly between 1.5 and 1.8 metres.

Engagement of both the city and homeowners in clearing back hedges that are restricting safe movement of pedestrians and bicycles along the pathway system.

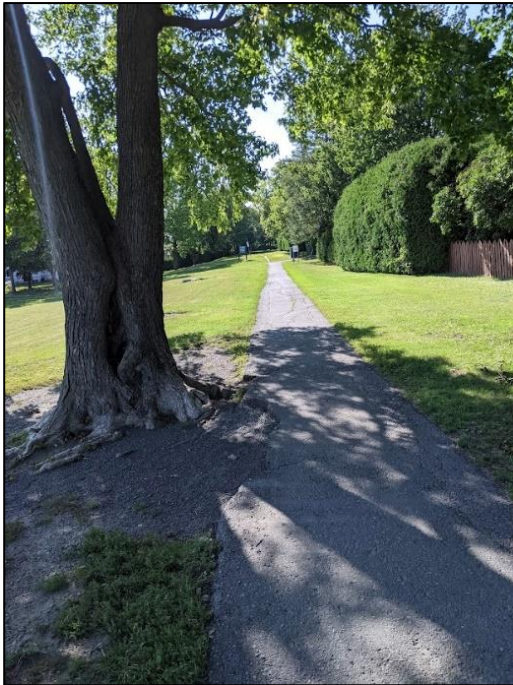
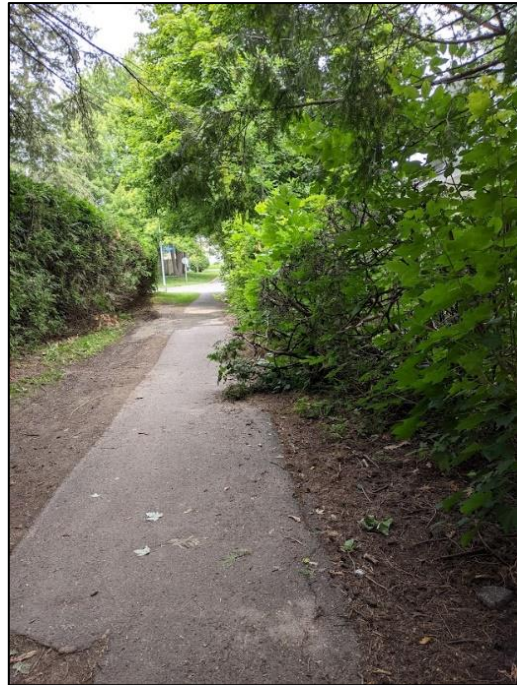
The pathways in this area lead to Blooming Gardens playground area and the Glen Oglivie school. They connect to the roadways of Woodhill Crescent and Westpark. Some areas of the pathways need immediate maintenance where there is missing asphalt. This is especially dangerous in the darkness hours because of no lighting. Other areas of the pathways have cracks that need to be addressed. There is also an overgrowth of a hedge that forces pedestrians and bicycles to move off the pathway.

The asphalt width of the trails in this area vary from is 1.5 to 1.8metres.

Develop a plan to immediately replace the asphalt in areas where it is identified as being a safety factor.

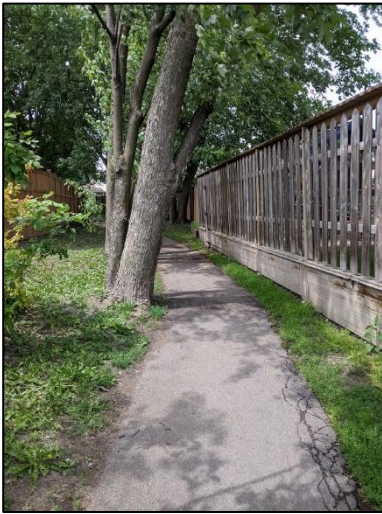
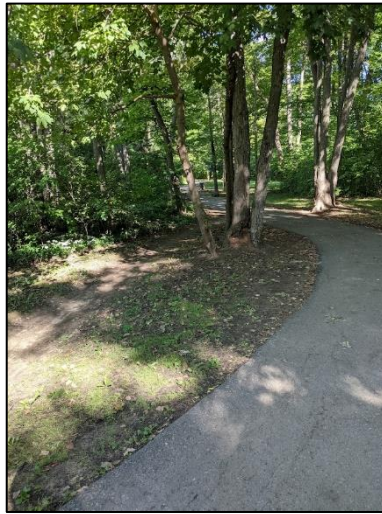
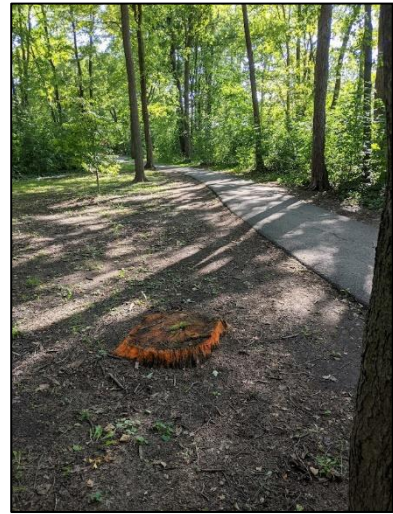
The pathways in these two parks are interconnected so the review includes both park areas. Their pathways connect to the roadways of Bearbrook, Nothpark, Ridgeburn and Diceman Crescent. The pathways in this area need immediate attention because of the restrictions of movement for pedestrians and bicycles, and the degenerating condition of the asphalt. There is also a safety concern on the pathways for both pedestrians and bicycles due to the increased growth of trees. The potential for the collisions of two parties is so high that users have been made alternate paths. While the removal of the trees is not a favorable option the city has done it in other parts of the pathway system.

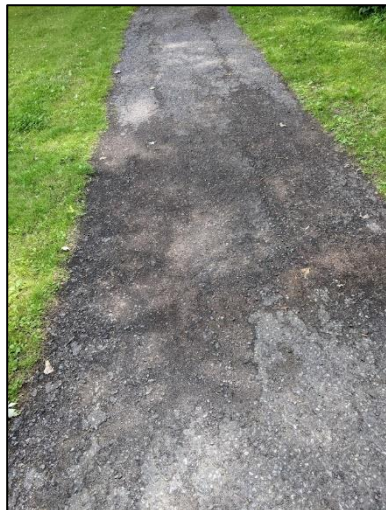
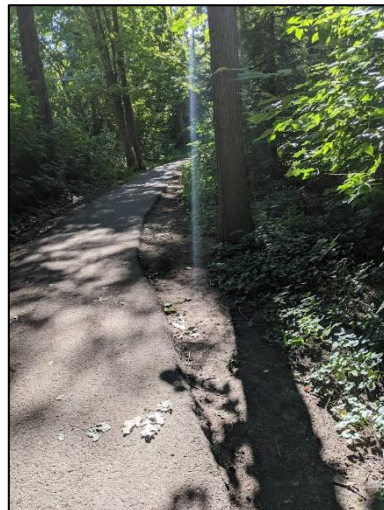
The asphalt condition in the Diceman Park area requires immediate attention. In some areas there is no asphalt remaining while in others areas the asphalt is badly broken. Many areas have cracks or uneven sections. Erosion of the pathways is also a major concern in this area.

Conduct an onsite review by qualified city staff to the soil erosion problem on the pathways, especially in those areas where accidents/injuries have occurred, and effect the solutions, as required.

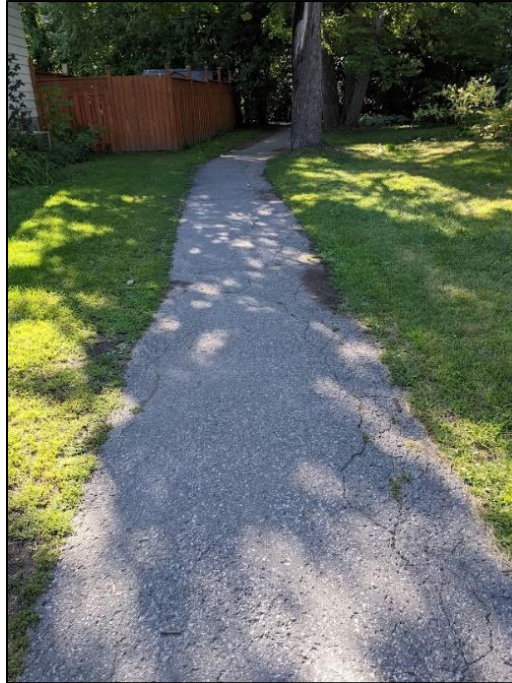
There is also one section of the pathway system that leads to a dead end.

The asphalt width in some areas of this pathway (Path 1) area is the least width of any pathway in the Hamlet. The general width ranges from 1.2 metres to 1.8 metres.

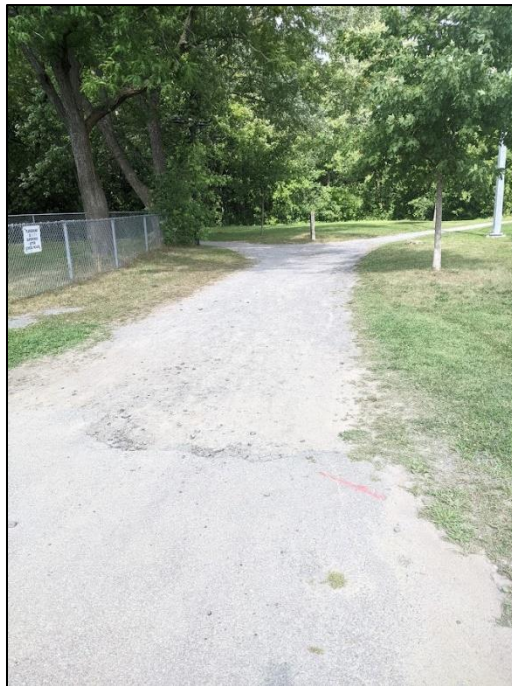
The pathway is quite narrow in some areas while only a small portion of the pathway is asphalt. The remaining pathway is earth base, with crushed rock in some places. Consideration should be given to a having this pathway completely asphalt covered. Its present width and solid base are ideally suited for asphalt.

The asphalt width in this area is mostly 1.5 metres whereas the non-asphalt portion of the pathways ranges from 1.5 to 2.7 metres.

Develop a plan to install an asphalt pathway from Orient Park to the arena area. This would entail improving upon the existing pathway.
